Gujarat Relief Engineering Advice Team (GREAT)
GREAT Publication: June 2001

Repair and strengthening guide for earthquake damaged low-rise domestic buildings in Gujarat, India

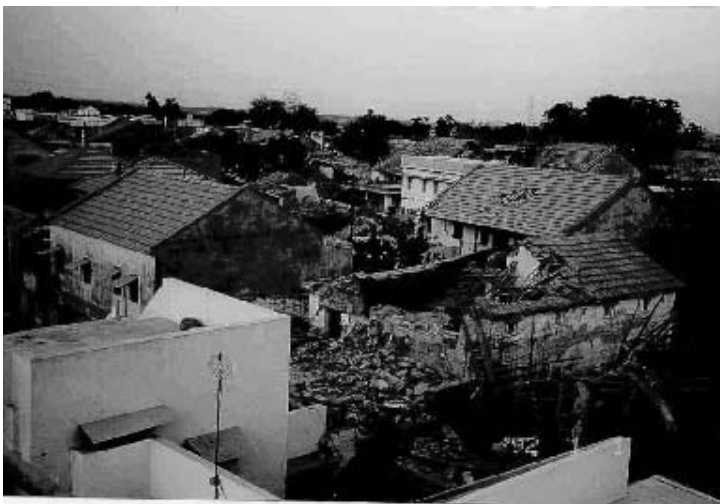
Even single storey buildings suffered severe damage and/or partial or complete collapse. Figure 3.1 and 3.2 shows some of the failure of these buildings.

Figure 3.1- Collapse of random masonry building in Manukawa

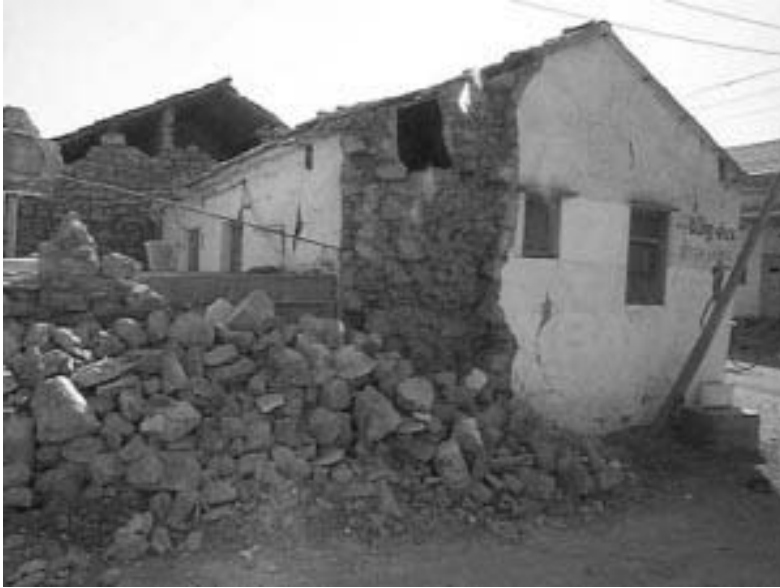
Figure 3.2 – Partial collapse of gable wall for a single storey random masonry wall in Kera

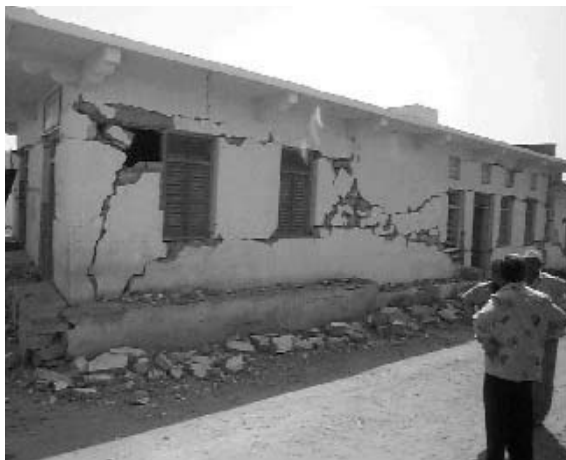
Figure 3.3 – Heavily damaged single storey rubble masonry wall with concrete roof in Manukawa & Sukhpur.

Walls survived due to diaphragm action from roof. Cantilever beams embedded in walls also helped this. Note window openings are also not close to corners.

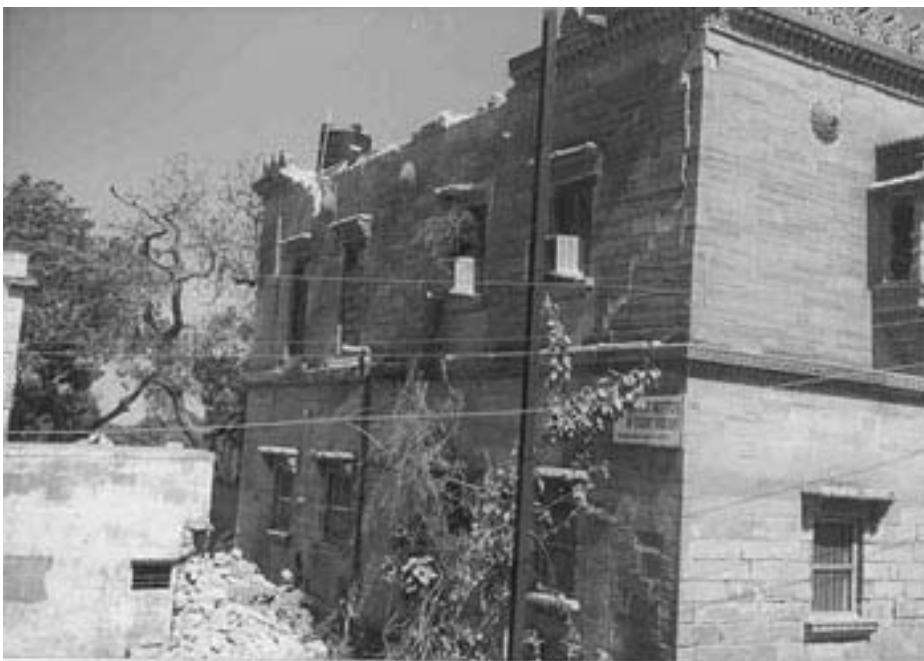
An old government building (predating 1900's) made with solid cut stone masonry walls is shown in Figure 3.4. This building received slight to moderate damage although it is in the centre of Bhuj and all around, rubble buildings have totally collapsed. The floors and roof are of timber and an adjacent similar building had cut-stone walls which were at least 0.5m thick. The upper storey wall is seen to be damaged at the edges by bending cracks caused by out-of-plane shear forces. Untied architectural stonework has also fallen off at roof level, as might be expected from severe shaking. The heavy wall units and regular stone blocks prevented collapse of these old buildings.

Figure 3.4 Cut-stone building in Bhuj

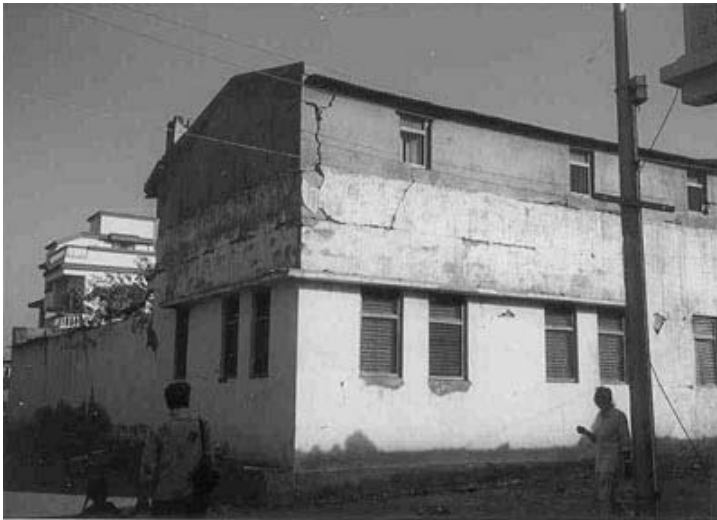
Figure 3.5 shows a two-storey modern cut-stone wall building near Bhuj, in town called Mirzapur. The building has cut-stone walls about 0.225 to 0.3m thick and has a 1st level concrete floor and a pitched timber roof. The window openings are not close to the edge and are also sensibly spaced. This is probably one of the main reasons why it survived with so little damage. Even so some vertical bending cracking has happened near to the corners, again due to out of plane shear forces.

Many buildings which did not collapse suffered from severe diagonal cracking at their corners, some with partial collapse at corners, primarily because of window openings being too close to the corner and because of lack of tothing between returns.

Figure 3.5 Modern cut-stone masonry building in Mirzapur

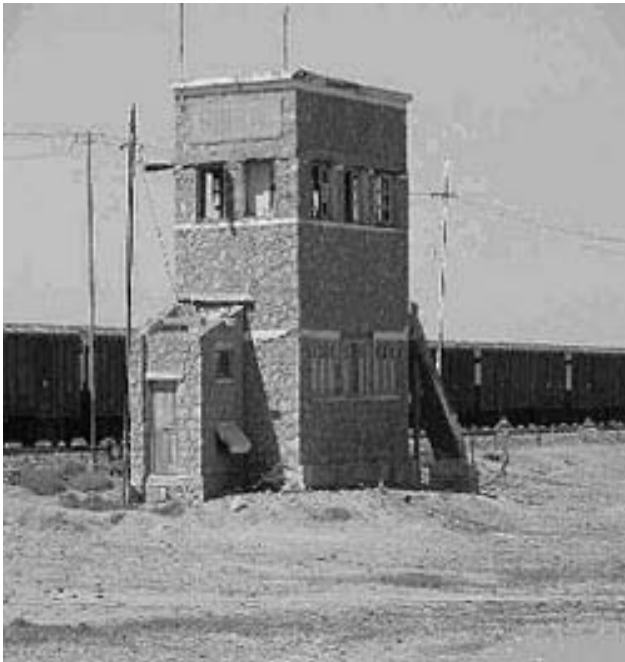
Seismic bands or ties greatly increase the strength of buildings in earthquakes. The railway lookout building in Figure 3.6 is made with random masonry, is well-constructed and is bonded with cement mortar and suffered very little damage. What sets this building apart from others that collapsed nearby, is that it has been designed with strong reinforced concrete seismic bands at lintel and cill level, which completely tie the four walls. There is also a flat concrete roof. The seismic shear force is resisted by the lintel and cill bands, and has clearly strengthened the building against repeated shaking from an earthquake which would make lesser buildings collapse.

*Figure 3.6:
Strengthening of buildings
by use of seismic bands*

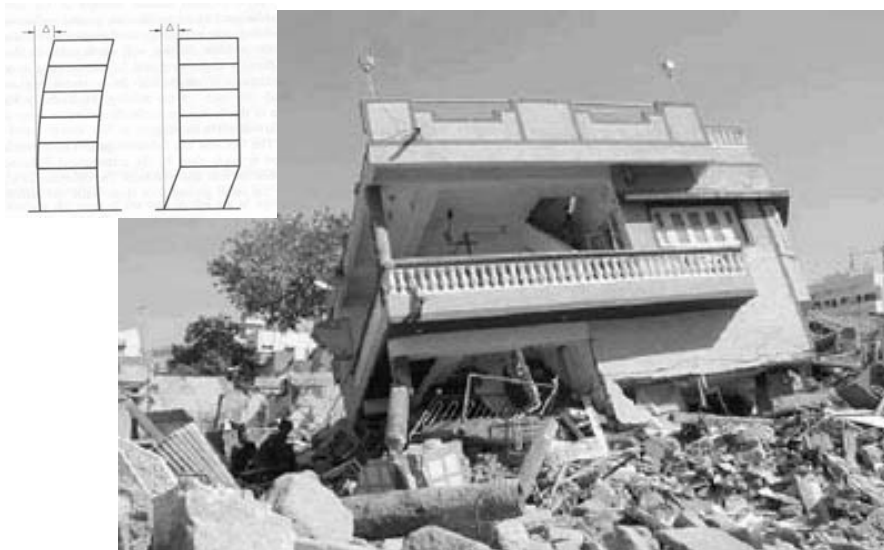
Some domestic reinforced concrete buildings had large internal openings or unsymmetrical masses at first or ground floor level. This caused severe structural damage and even collapse. Figure 3.7a shows a building, which collapsed because part of the floor area was converted to an opening for car parking. The building was subjected to torsion about its centre of rigidity and failed because of soft storey behaviour with large deformations and rotations concentrated at the top of the columns (Fig 3.7b).

Figure 3.7a – Typical soft storey and torsion collapse in Bhuj

Fig 3.7b The inset shows large deformations were concentrated at column heads, which caused many soft storey failures, as per picture. Buildings if designed with uniform deflections as per left diagram of insert would have survived without collapse.

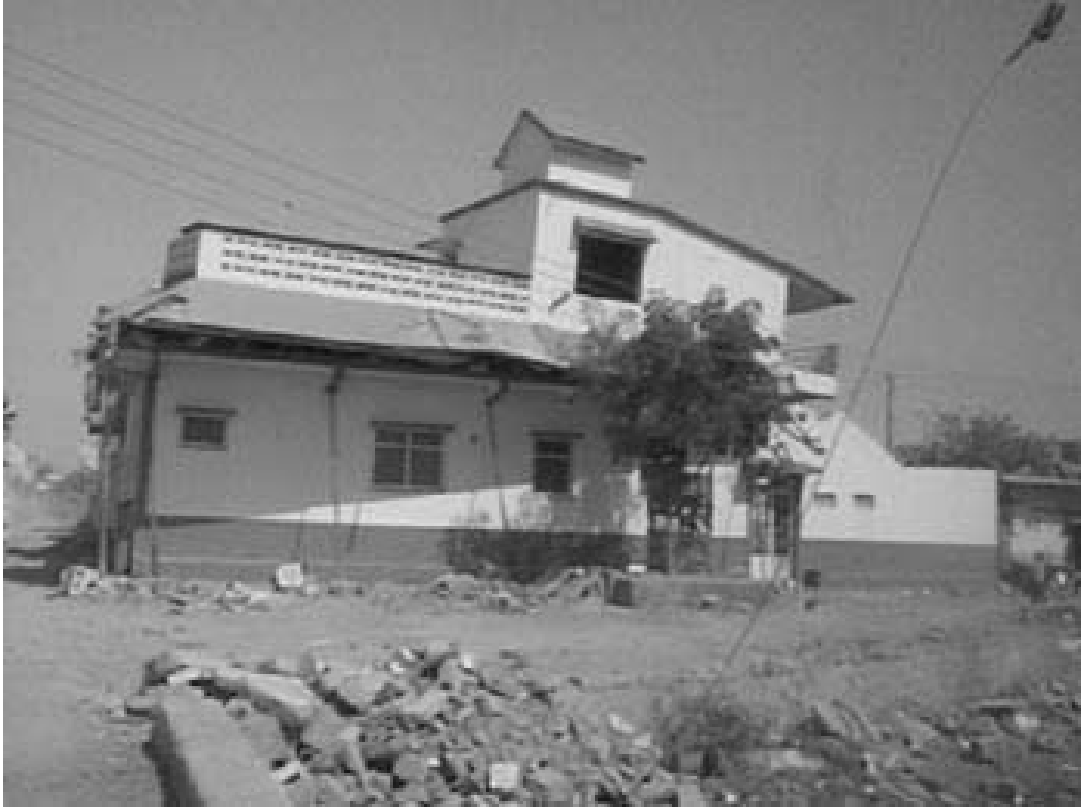
Figure 3.8 shows a building where the owner had a middle floor supported on columns with large internal open spaces, and hardly any masonry infill walls. Under seismic loading, large deformations occurred at the top and bottom of the columns and a soft storey collapse occurred, the upper floor storey falling onto the first storey. This shows that soft storey collapses do not always occur at ground floor.

Figure 3.8 – Soft storey second floor collapse in Sukhpur

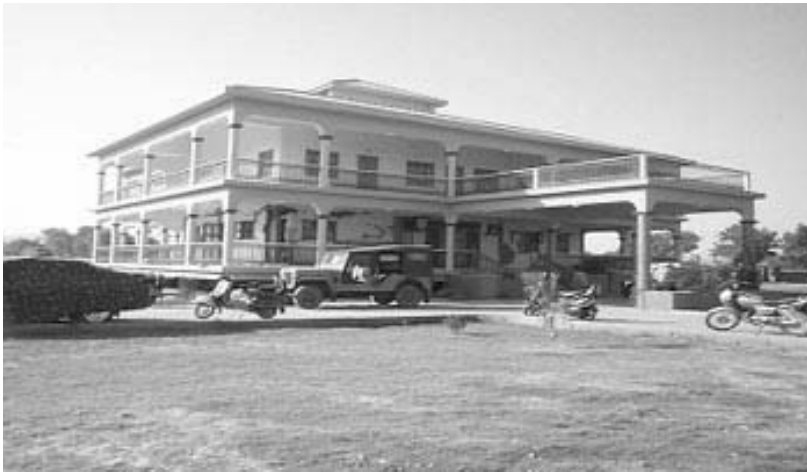
Figure 3.9 shows the effectiveness of shear walls in preventing an RC framed building from collapse. This building experienced severe shaking causing moderate to heavy damage to the infill panels, but this prevented column failure. Many infill panels in these types of buildings will need to be restored following the earthquake. It should be noted that this wall was effective despite being compromised by the presence of a door opening.

Figure 3.9 Infill panels to an reinforced concrete frame building acting as non-structural shear walls, provided stability to the overall frame – Bharasar

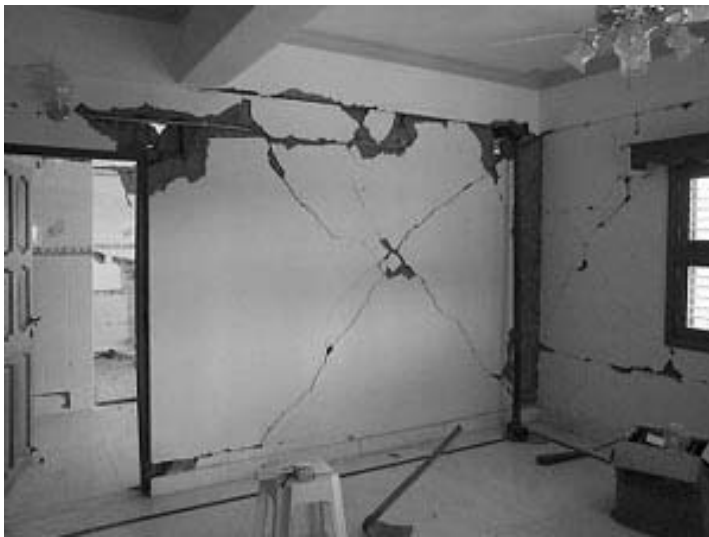
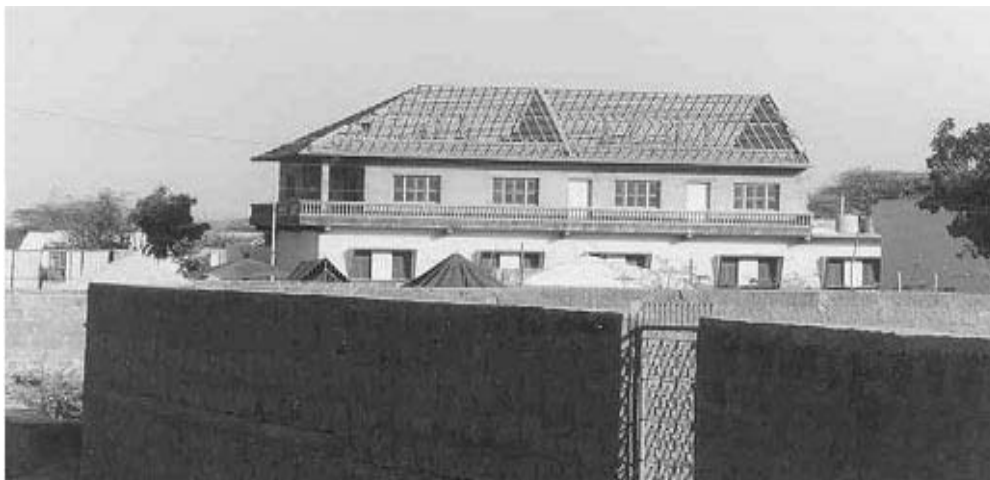
Figure 3.10 Infill panels again prevented collapse of this structure although all the roof tiles fell off - Mirzapur.

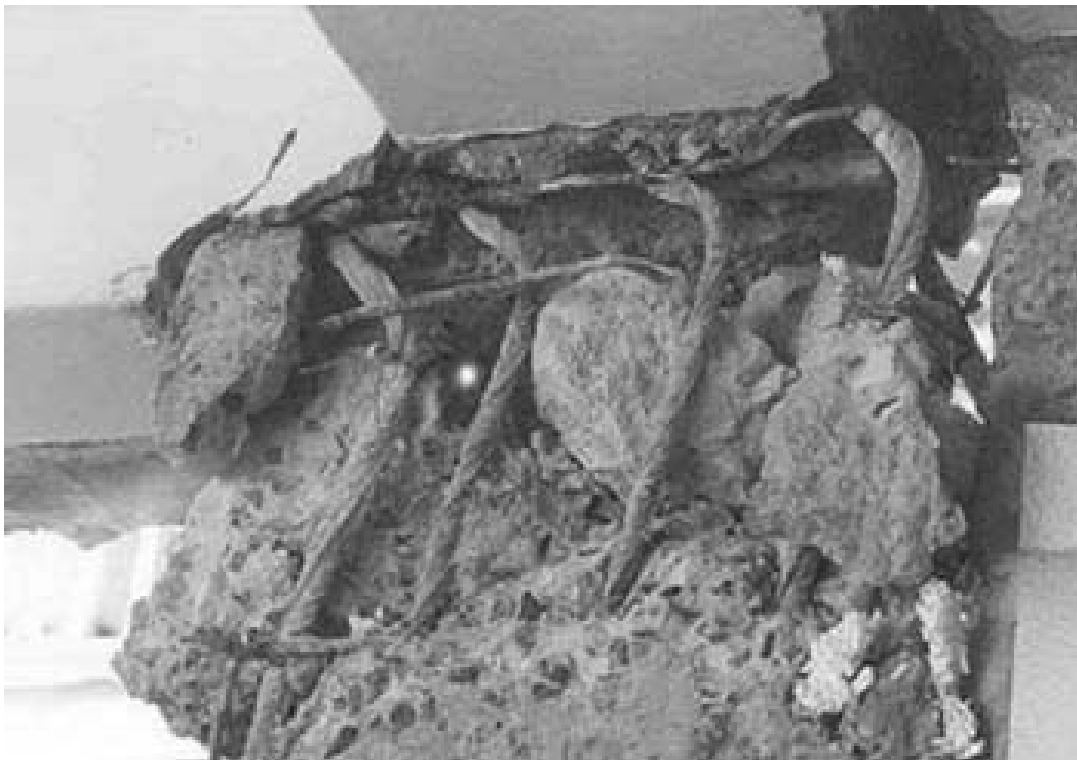
When masonry infill walls were ineffective because of large openings, column heads were subjected to large vertical and lateral seismic forces. The heavy eccentric compressive stresses crushed column heads and large shear deformations caused concrete to spall away from the main bars because of links being too far apart. The extent of damage to the column heads often depended on how well the infill wall panels were bonded to the columns. Figures 3.11 and 3.12 give examples of this.

Figure 3.11: Heavy compressive stresses with large deformations causing total destruction of column head with heavily bent main bars. Concrete not contained by links because they were too far apart.

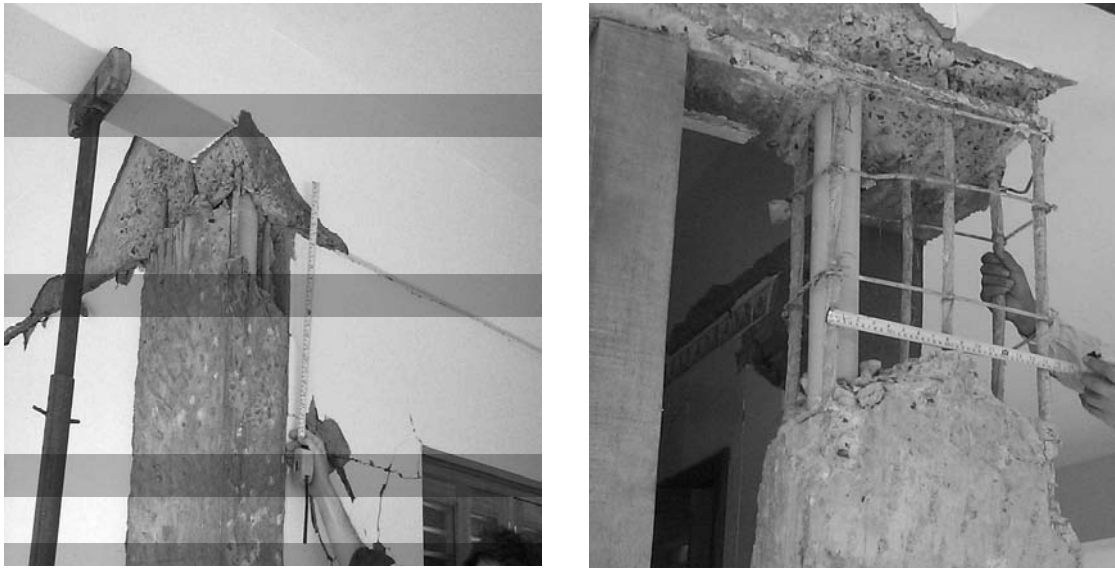
Figure 3.12 A column that survived with minimal distortion as infill walls performed well and repairs being carried out to damaged column head showing minimal distortion to main bars (right)

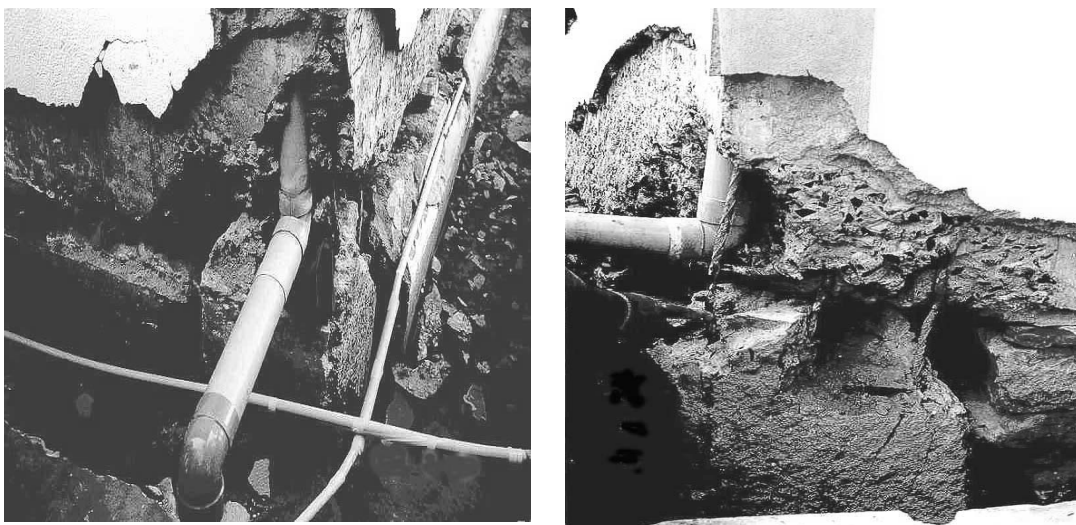
- (1) Drain pipes and other services placed inside columns, caused severe weakening of the columns making it less resistant to lateral loading;
- (2) Shear link spacing was too large (typically 200-300mm), thus not providing adequate confinement to the main bars, causing concrete to fall out;
- (3) Links were not bent backwards into the columns so they easily separated, again letting concrete out of the main bars;
- (4) Very small links (6mm diameter) were used;
- (5) Main bars were not bent back into the floor or ground beams so that reversal of shear loads could not be resisted by the beam and column connections. Many failures occurred at beam/column junctions, see Figure 3.13.

Figure 3.13: Separation of ground beam and column junctions caused by concrete crushing in Sukhpur. Damage made worse by the weakening presence of a plastic pipe within the column.

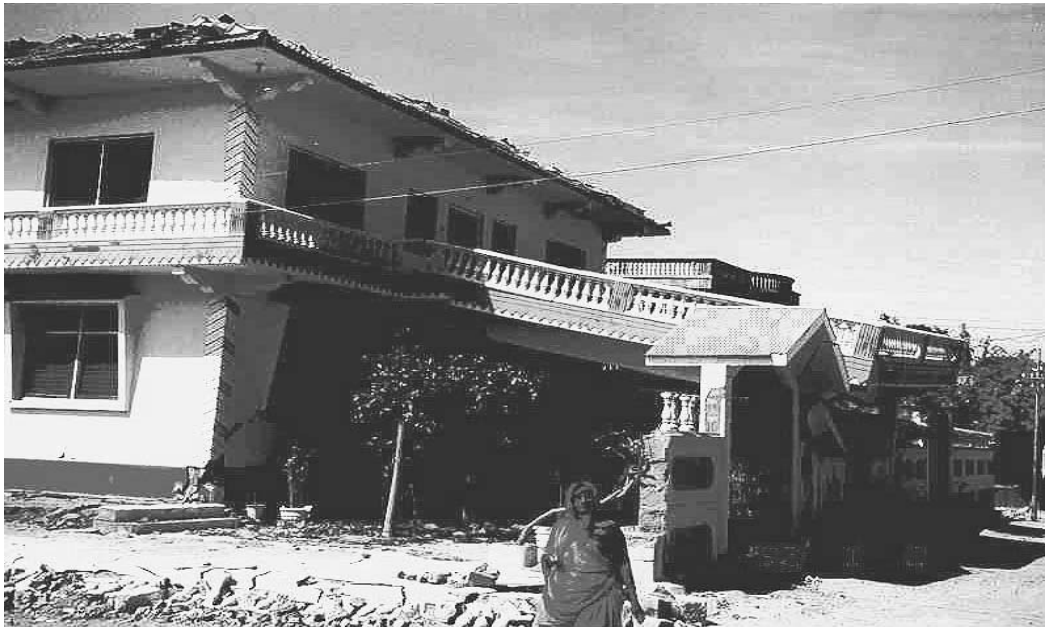
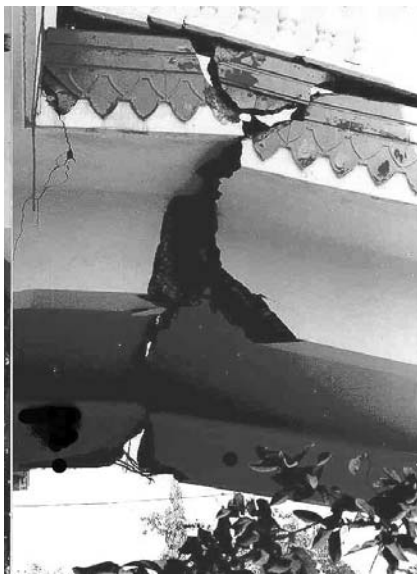
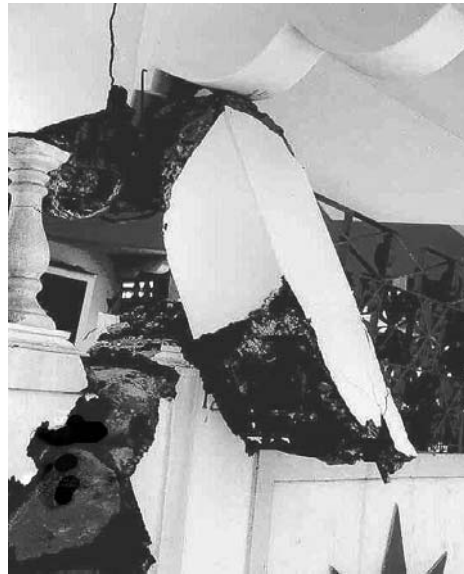
Several modern buildings had a single storey canopy with a flat roof supported by columns at one end and beams running into the main structural frame at the other end. These suffered varying degrees of damage depending on how slim the columns were, see Fig 3.14.

Beam Fracture

Snapped Column

Fig 3.14 Collapse of a canopy structure due to column failure

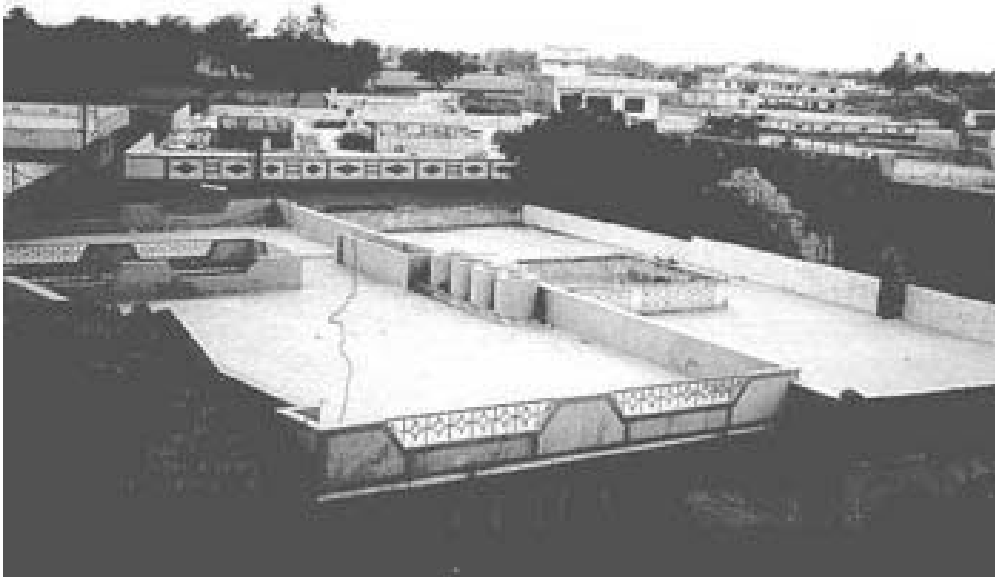
Smaller storage containers built on top of the roofs were either located directly on flat roofs or on short columns. These either slid along the roof breaking water pipes or sometimes toppled over when the short columns fractured. There was no evidence that the smaller header tanks were responsible for structural failure of 2 storey domestic houses.

Figure 3.15 Flat roofs with small water storage containers - Madhapur

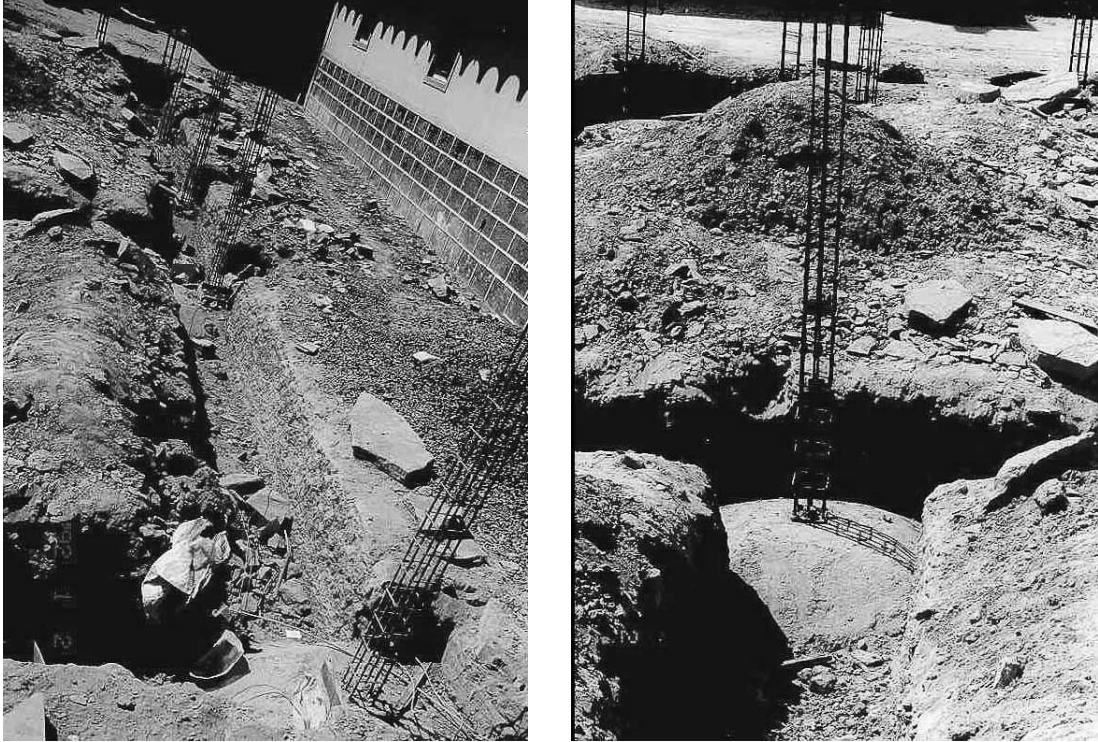
There were however many examples of poor detailing to columns, ground beams and foundations. Figure 3.16 show one example of poor detailing of column to base, with typical link spacings over 250mm to a very slender column.

Figure 3.16 Poor reinforcement detailing for an Reinforced Concrete frame building about to be constructed in Sukhpur

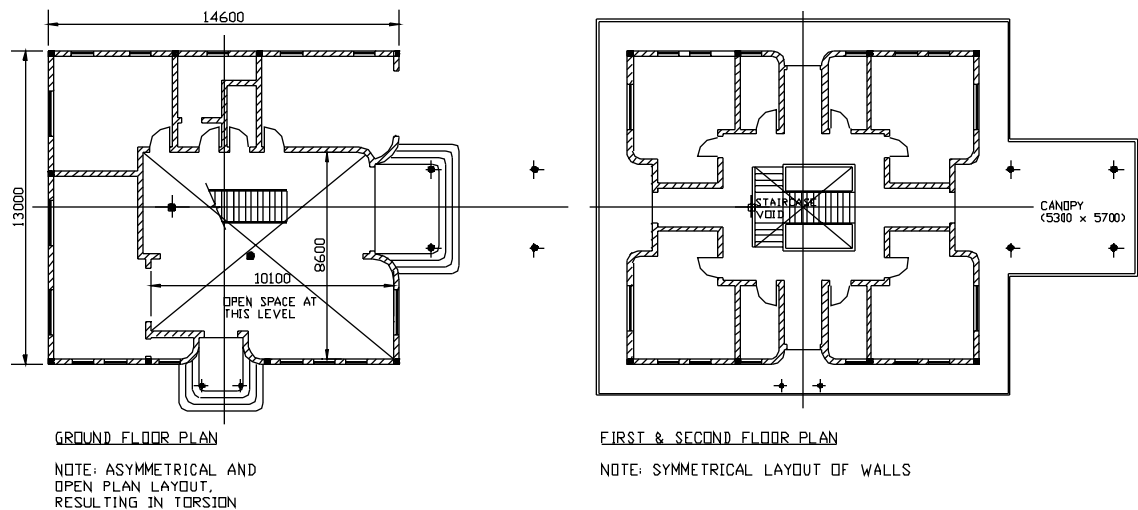
Figure 3. 17 Floor plans

- a) **Poor building configuration (resulting in torsion during earthquakes).** The ground floor plan was asymmetrical (L-shaped internally) relative to the floors above. As a result, the whole building at ground floor level has twisted clockwise under the heavy mass from the floors above. Severe damage has occurred to the walls and columns at ground floor level, see Figure 3.17. The reason for the L shape plan at ground level was because the owner wanted a large open plan living room area.

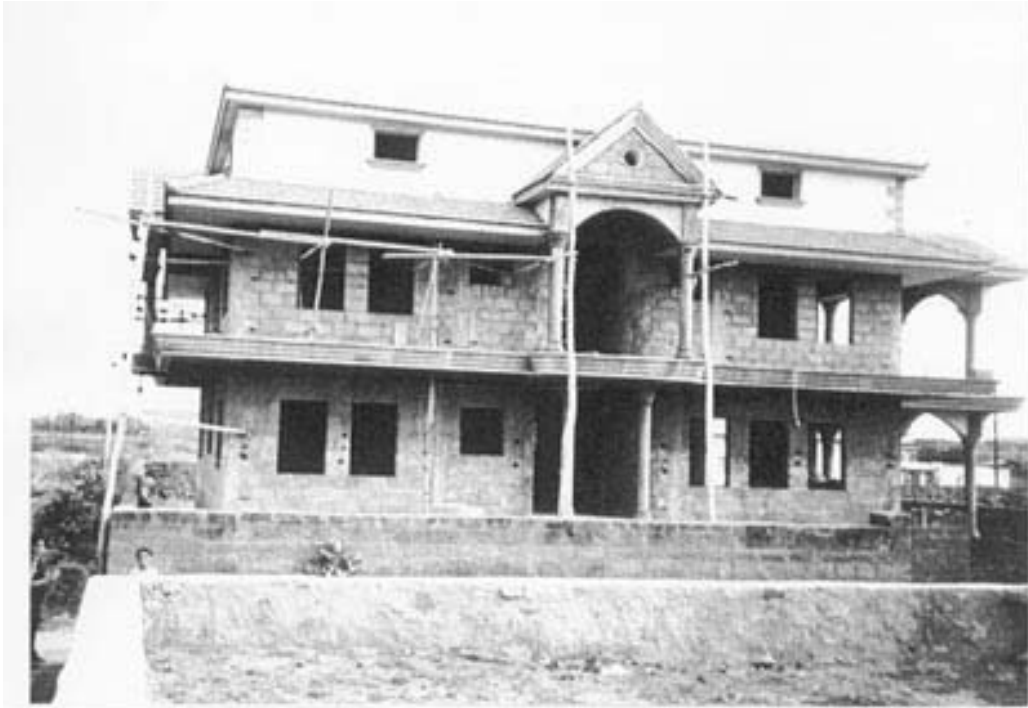
- c) **Large window openings.** Figure 3.18 also shows that the window openings between columns are large, exceeding the limit of 33% of total wall length as advised by the Indian codes for a three storey plus roof structure. The ability of the masonry blockwork walls to resist shear is thus diminished due to lack of continuity. Diagonal cracking has occurred through the masonry wall and columns. Other photos show that the bond between the

Figure 3.18 Building under construction one year prior to earthquake

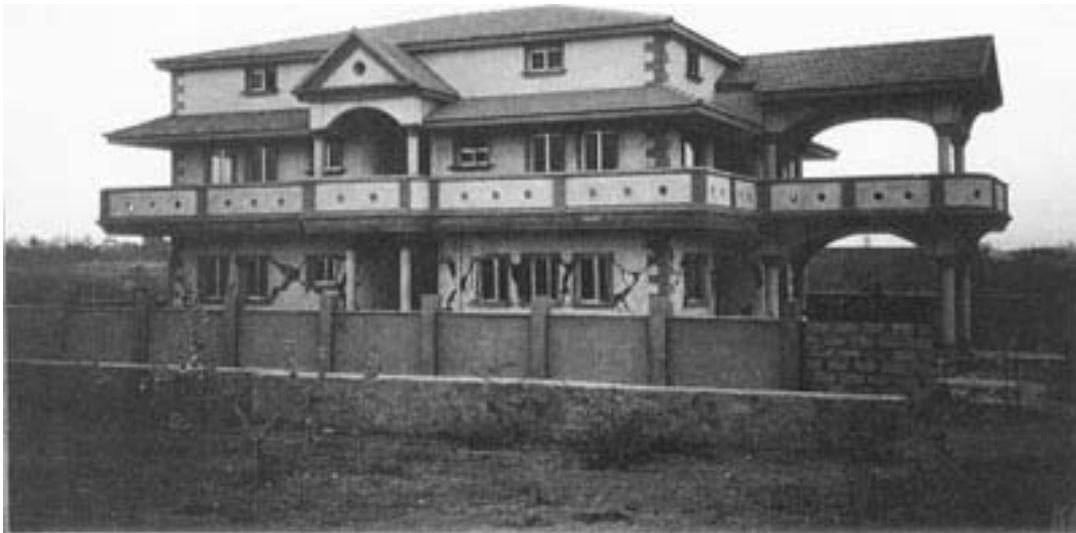
Under the action of the seismic shear and torsional effects, the damage to this building was largely concentrated at ground floor level with upper floors remaining intact and undamaged. The first floor concrete slab and beams were undamaged by the earthquake.

Figure 3.19 Damage to completed building after earthquake

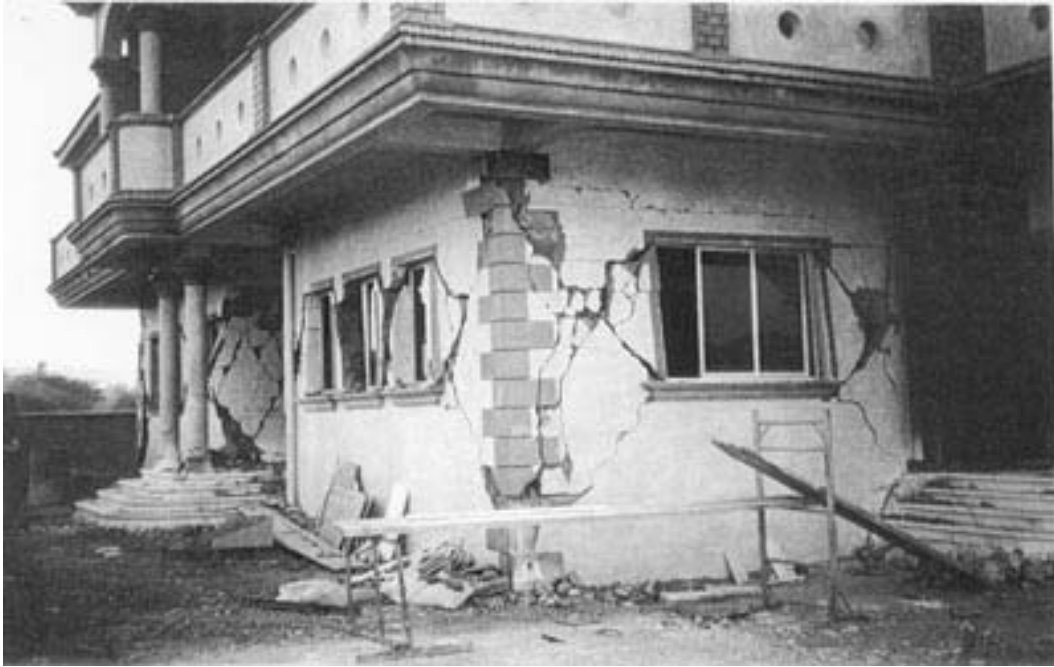
- d) **Short column failures.** Short column failure (diagonal cracking) can be seen to have occurred over the mid height of all the external concrete columns (these were 225mm square) and through the masonry columns. This is because when infill walls with wide openings are attached to columns, the portion of column that will deform under lateral seismic loading becomes very short compared to its normal height. Such short columns become much stiffer and attract much larger shear forces resulting in severe diagonal tension and cracking failure in the columns. This failure is plainly seen in Figs 3.19 and 3.20. The problem was magnified because plastic service conduits ran inside some of the corner columns and walls, reducing the column stiffness.

Figure 3.20 Large window openings close to corners and short column failures

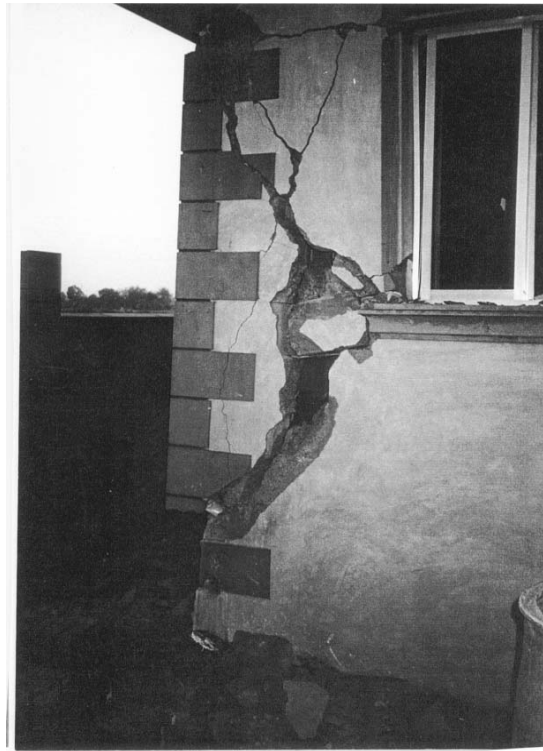
Figure 3.21 Diagonal cracking at corner column caused by twisting of frame and short column failure.
