Report on Field Visit of Sunkoshi/Bhotekosh Landslide Affected Area

A report produced by DPNepal Nepal

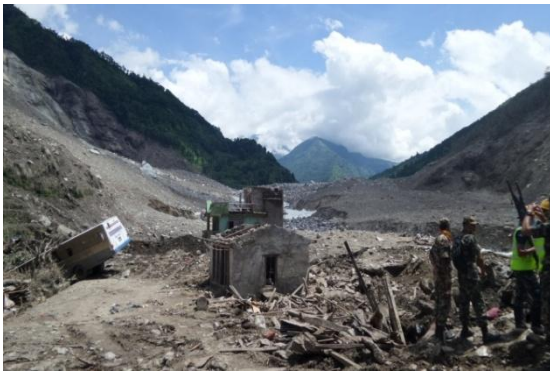
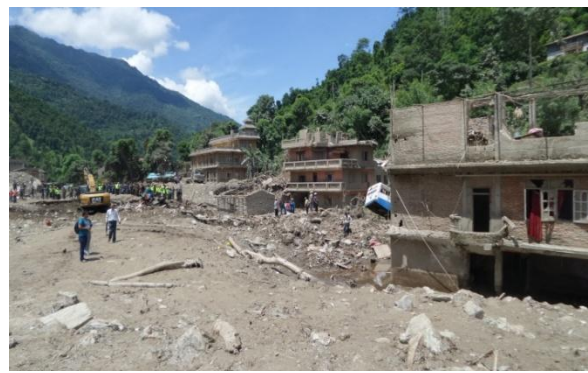
The landslide claimed 156 lives and many more livestock. The event has displaced about 436 people. The highly affected 4 VDCs are Ramche, Mankha, Dhuskun, and Tekanpur. About 165 houses were damaged completely (Ramche 60; Mankha 79; Tekanpur 17; Dhuskun and 9) whereas about 37 households were partially damaged. Approximately 27 people have been injured and are under treatment in Kathamndu.

Damages and collapsed building (photo: Hari Darshan Shrestha)

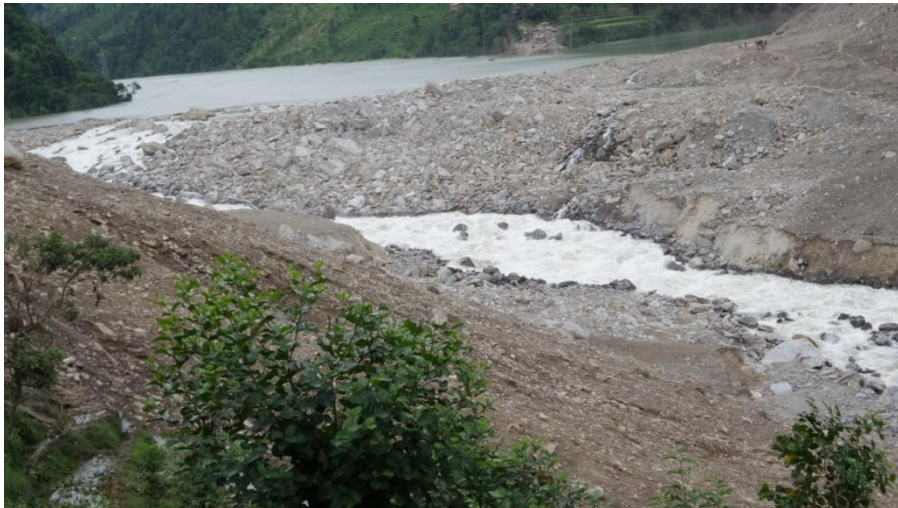
- The landslide suddenly displaced the Sunkoshi River flow with debris which resulted in a massive wave of about 100 meter towards the left bank of the river. The wave resulted in destruction of the forest area on the left bank of Sunkoshi River up to a height of 100 m.

- The debris deposit across the river created a massive landslide-dam which was completely filled in about 12 hours, after which the river started overflowing.

- The volume of impounded water due to damming is estimated to be around 7.4 million cu.m, creating a lake of about 2.5 km long and submerged an area of about 400 hectare in the upstream. It is estimated that the depth of water in the dam is about 46.7 m (technical team NEA/DPNET).

*The landslide-Dam and the part of the lower end of the lake . Viewed from the downstream side.
(photo: Hari Darshan Shrestha)*

- The river flow in the upstream and downstream of the dam is almost equal on the day of the field visit. Nepal Army is putting great effort to increase the discharge of water from the lake.
- The DHM staff is monitoring the flow at upstream and downstream of the river which seems to show a balance between inflow and outflow, considering gradual lowering of water impoundment in the reservoir created by the landslide dam.
- No leakage of water from the visible portion of the landslide dam was observed even after 72 hours of impoundment and overtopping flow. The overburden pressure of the rocks has been withholding the upstream water pressure.
- The risk of a dam break is still there, but expected to be low due to mass of debris deposit, type of material and width of the landslide dam.

- Early warning system in downstream – 24 hour monitoring of the reservoir water level & dam, and installation of a series of sirens and vehicles fitted with siren ready to move in different location for the safety of the people living close to the river in the downstream stretch.
- Gradual controlled increase in the reservoir outflow.
- Evacuation strategy, emergency escape route and camps – A study on dam break scenario or flood hazard to map potential damage and inundation area, in case of a dam break

- Study of material and nature of Dam
- Study on landslide to see possibilities of further landslide
- Survey and define the area, depth and actual volume of water
- After study of nature of dam, decide to strengthen or lowering the dam and discharge water in controlled manner
- Immediate construction of bypass alternate road to Kodari, if feasible
- Recovery and Reconstruction strategy

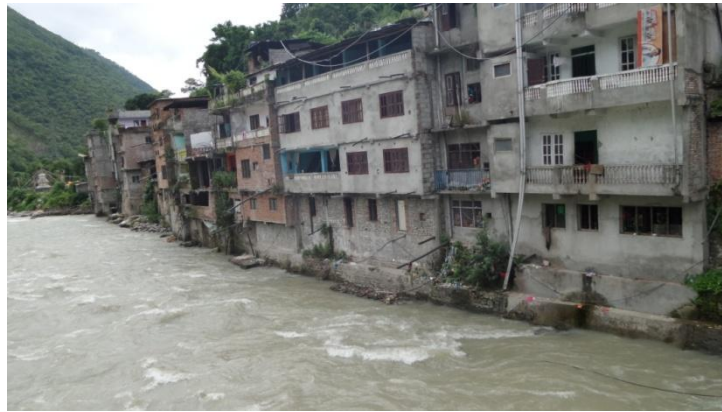
Khadichaur Bazar at risk – downstream (photo: Hari Darshan Shrestha)
