SEISMIC RETROFITTING GUIDELINES

OF
BUILDINGS IN NEPAL

2013

ADOBE STRUCTURES

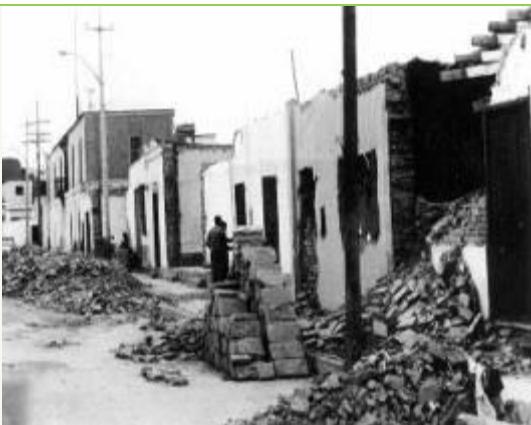
Figure 2-1 Severe damage to adobe buildings in Chorrillos district in Peru earthquake 1974

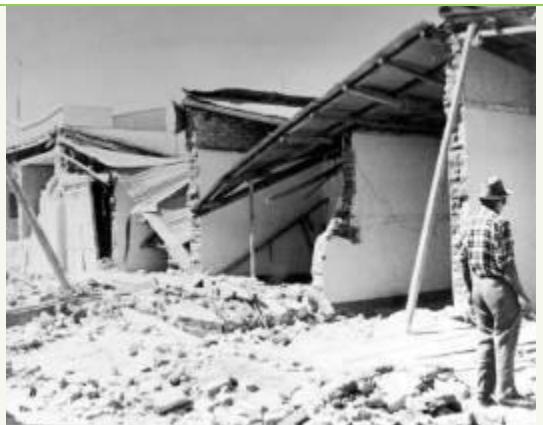
Figure 2-2 Damage of adobe houses in Guatemala City during Guatemala Earthquake 1976

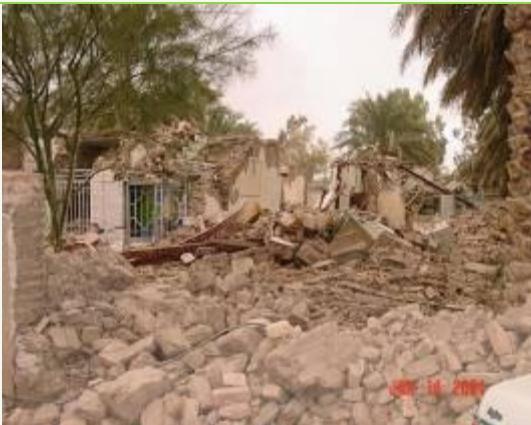
Figure 2-3 Collapsed adobe structures 2003 Bam Earthquake

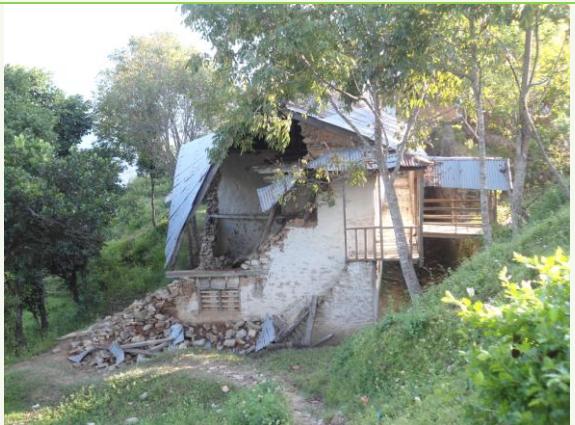
Figure 2-4 Collapsed structure (source: CoRD)

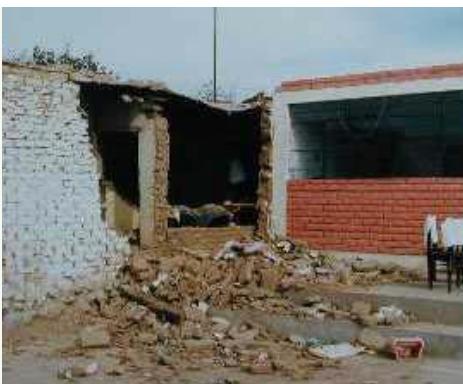
(Source: Report #52 in EERI/ IAEE World Housing Encyclopedia)
Figure 2-7 Out-of-plane wall collapse – 1996 Nazca earthquake, Peru

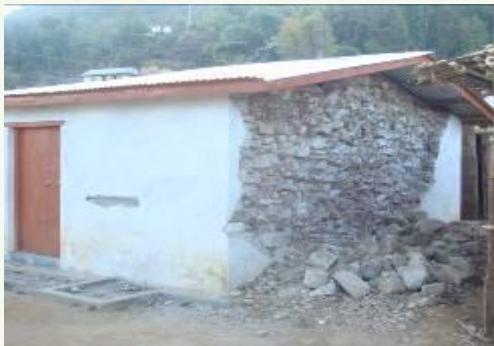
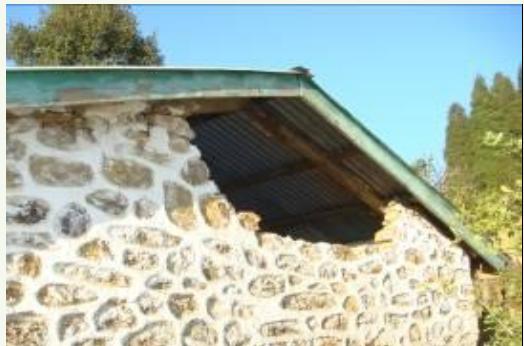
Figure 2-11 Some other examples of Gable wall damage during Eastern Nepal Earthquake, 2011 (Photo: CoRD)

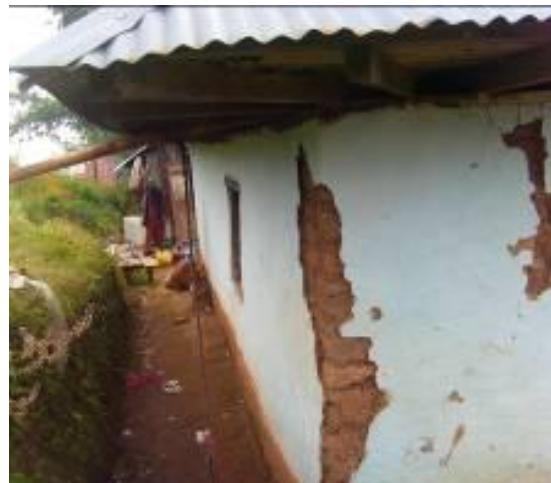
Figure 2-17 Corner damage during Eastern Nepal Earthquake, 2011 (source: CoRD)

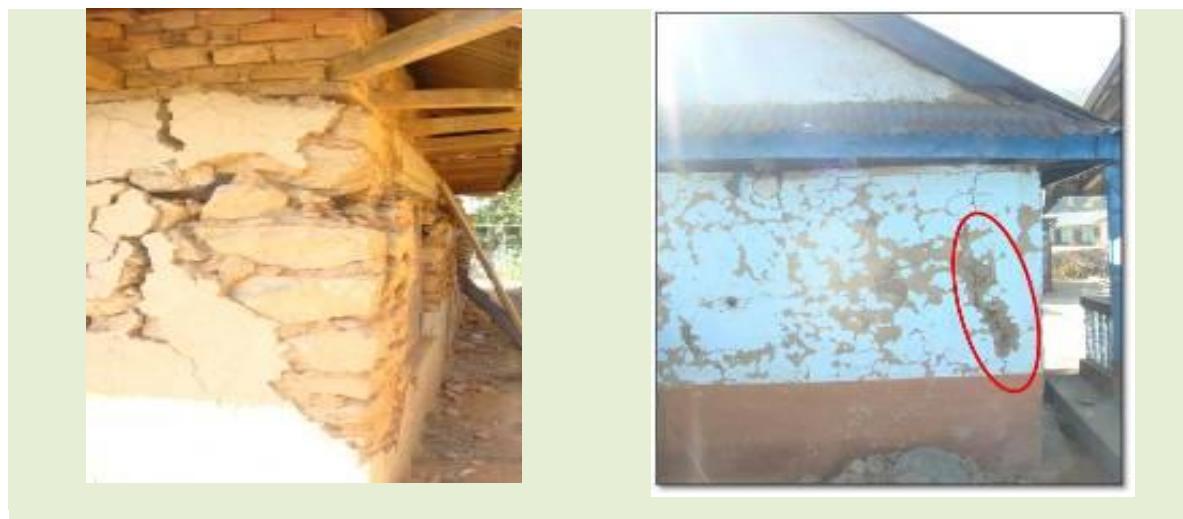
Figure 2-18 Some other examples of corner damages (Source: CoRD)

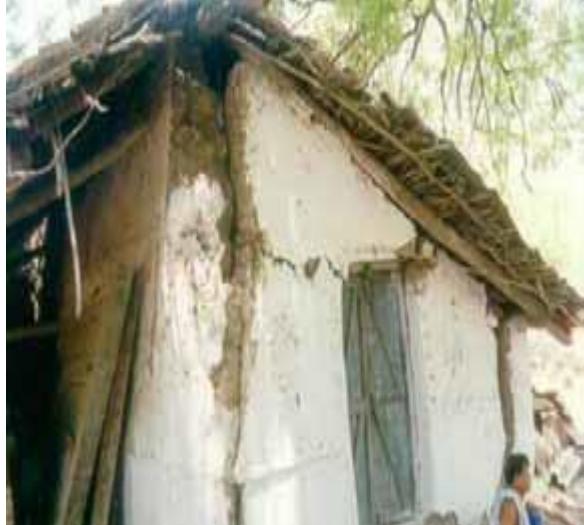
Figure 2-19 Vertical cracking and separation of adobe walls after the 1997 Jabalpur, India earthquake (source: Kumar 2002)

Vertical cracks often develop at corners during the interaction of perpendicular walls and are caused by flexure and tension due to out-of-plane movements. This type of damage can be particularly severe when vertical cracks occur on both faces, allowing collapse of the wall section at the corner (Figure 2- 19).

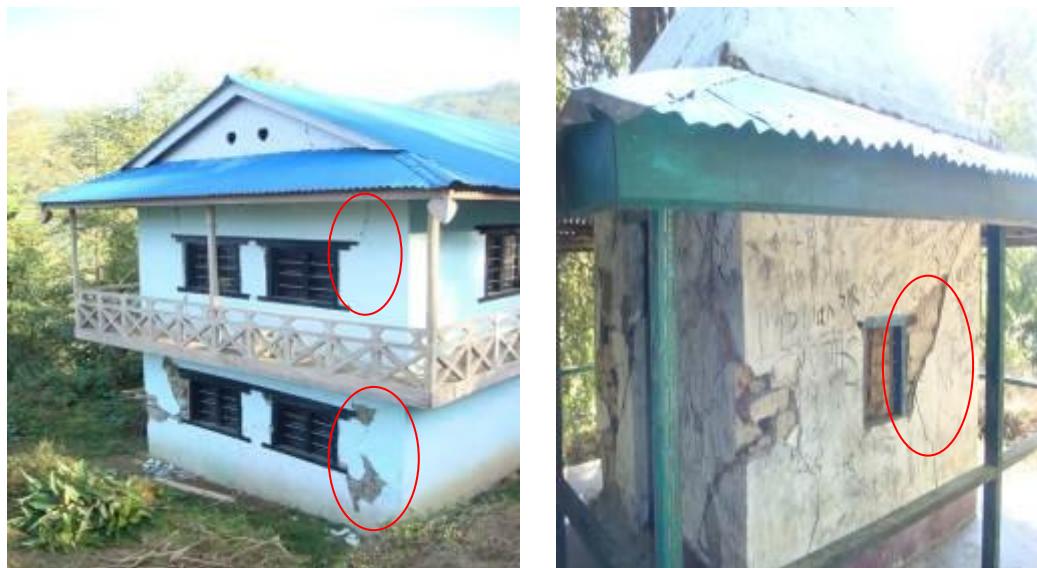
Figure 2-24 Some examples of Cracks at opening (source: CoRD)

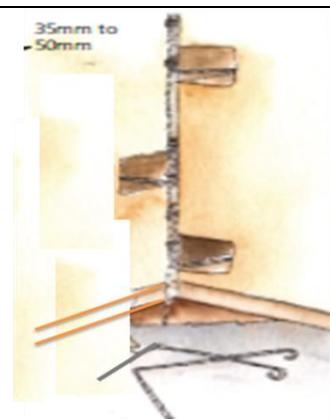
Figure 4-7 Vertical bar in corner (source: UNDP, UNECO & GOI, 2007)

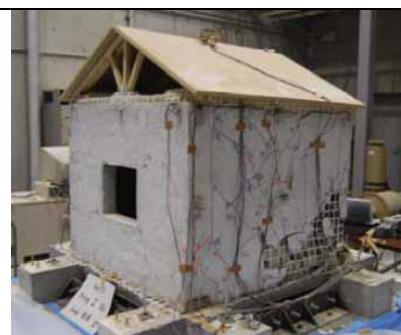
Figure 4-14 Full scale adobe model reinforced with pp band after a shake table test

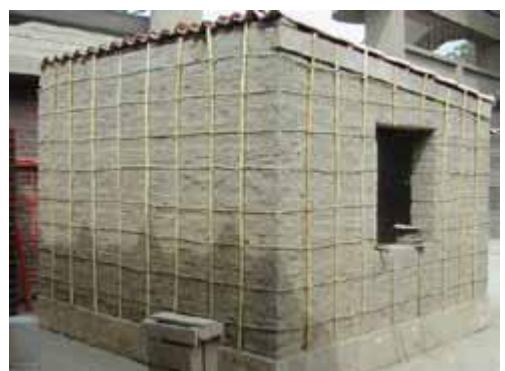
Figure 4-21 cane reinforcement

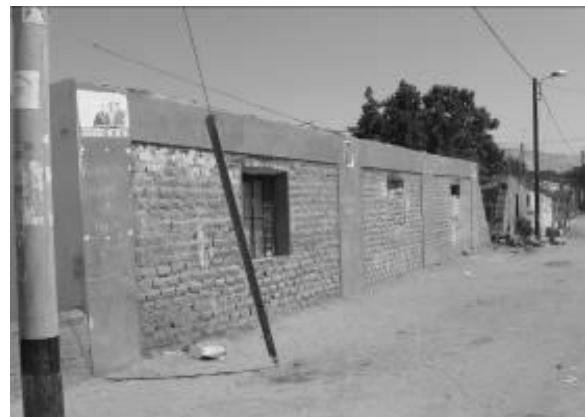
Figure 4-23 Reinforced house (Pisco Earthquake 2007)

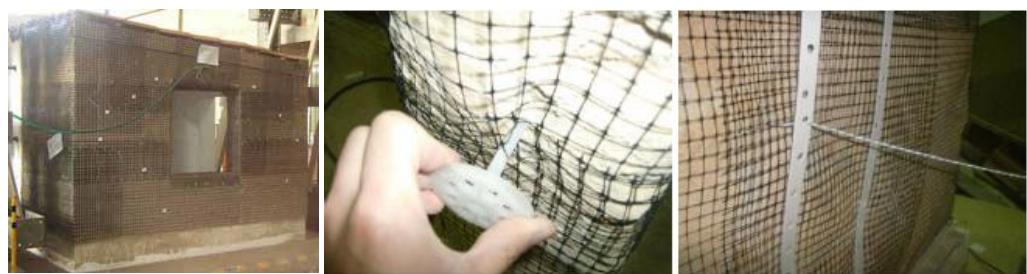
Figure 4-24 Reinforced house with geomesh (Source: world housing tutorial)

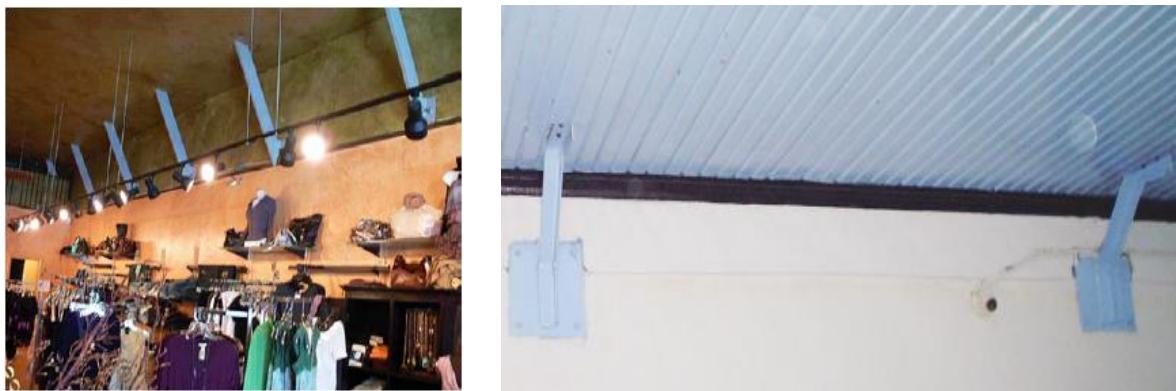
Figure 4-31 Roof to wall connection
