# Catchment-scale flood hazard mapping and flood vulnerability analysis of residential buildings: The case of Khando River in eastern Nepal

**Study region:** This study considers the Khando River (a tributary of Koshi River) in eastern Nepal. **Study focus:** To quantify the hazard and vulnerabilities across one of the frequently flooding catchments, i.e. Khando River, we conducted flood hazard assessment for 20, 50, 100, and 200 years return periods. We coupled flood hazard analysis with vulnerability analysis of the most dominant construction system along the river channel, i.e. wattle and daub houses. Based on the measured inundation depths, we created vulnerability and fragility functions. The flood hazard maps, damage mechanisms due to the 2017 flood, and vulnerability, as well as fragility, curves are reported in this paper.

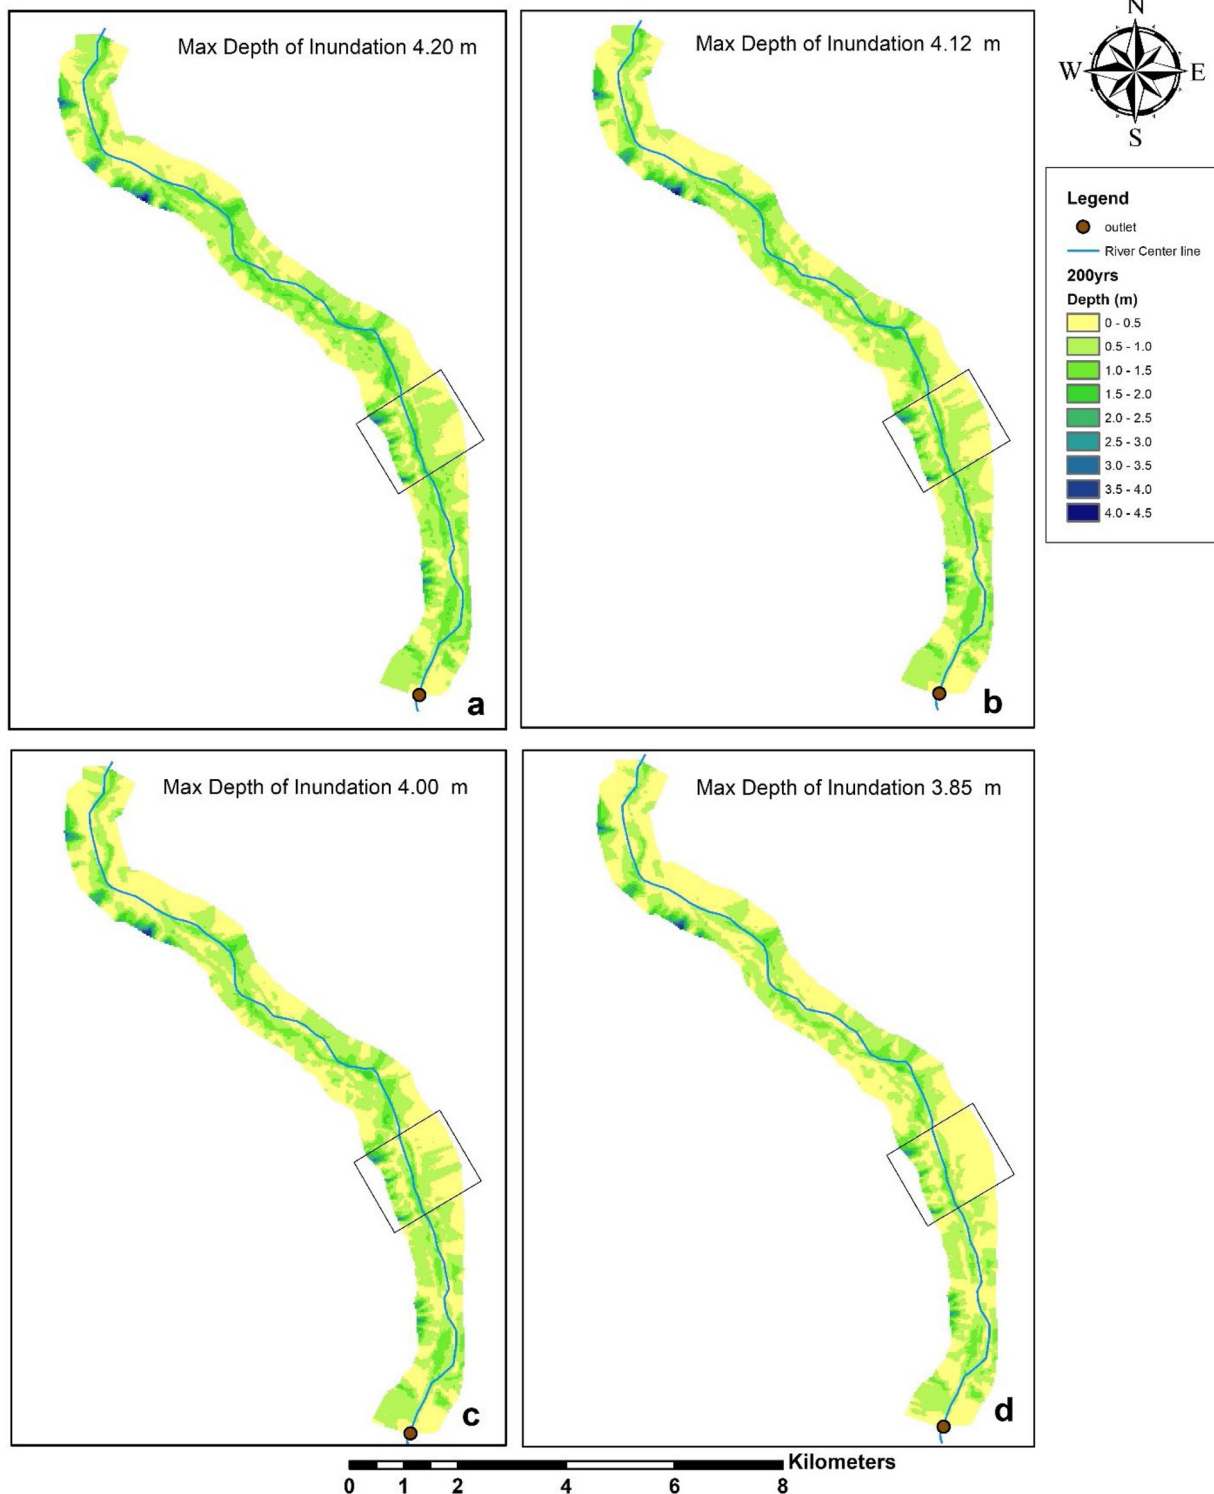
### Flood Hazard Maps for Khando River

Fig. 3. a) Inundation map for 200 years return period, b) inundation map for 100 years return period, c) inundation map for 50 years return period, and d) inundation map for 20 years return period.

First, we obtained discharges for 20, 50, 100, and 200 years return periods. The instantaneous flood discharges were obtained as 408, 534, 660, and 754 m<sup>3</sup>/s for 20, 50, 100, and 200 years return periods. Fig. 3a shows that the maximum inundation depth for 200 years return period is 4.2 m. Most of the areas across the catchment depict the inundation depth between 0.5–2.5 m for 200 years return period. Fig. 3a, b, c, and d highlight that the inundation depth was less in the left bank of the river due to higher topographical relief than the right bank.

As shown in Fig. 3b, the maximum inundation depth is 4.12 m for 100 years return period. The maximum inundation depths for 50 and 20 years return periods were obtained as 4 and 3.85 m respectively. The variation in the maximum inundation depth is not wide possibly because there is no significant elevation difference between the river channel and adjoining areas. Channel shifting and formation of artificial levees due to aggradation would act as the border between the river and agricultural land. This peculiarity sometimes leads to high inundation depth even beyond the river channel. Channel shifting in the Khando River occurs primarily due to the occurrence of loose soil and subsequent erosion. Fig. 3a, b, c, and d collectively delineate that with the decrement in inundation depth, the larger fraction of the catchment would be less inundated. This means when the maximum depth of inundation decreases, more areas tend to be exposed to less than 0.5 m inundation.

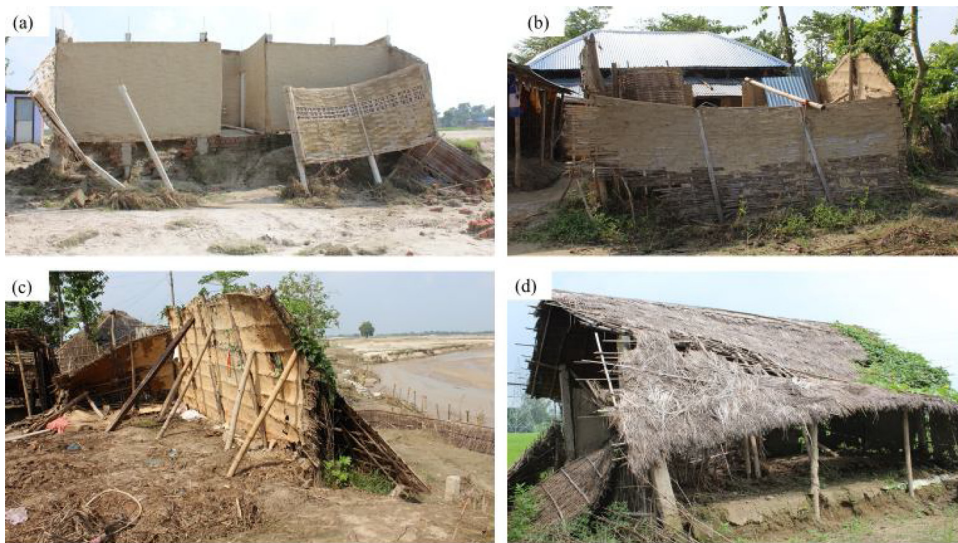
**Fig. 4.** a) Wattle and daub house partly damaged by flood, b) a destroyed wattle and daub house restored for temporary use, c) remains of a building (one wall) as three other walls were destroyed by the flood, d) a distorted wattle and daub house with collapsed and washed away walls.

After the 2017 flood in central and eastern Nepal, we conducted field surveys in the affected areas; mainly in Sunsari and Saptari districts in eastern Nepal. The survey was dedicated to assessing the damage mechanisms and damage levels in affected structures and infrastructures. The major damage location was across the Khando River in Saptari district. The most affected building form was the wattle and daub system. Similar observations were made also in Sunsari district. Wattle and daub constructions are low-cost folded bamboo constructions with thatched or galvanized iron (GI) roofing with bamboo or concrete post with marginal (usually single) reinforcement that would be available in the local market. Wattle and daub buildings are usually one to two-storied constructions that usually do not have specific foundations. Rather, bamboo or concrete pillars inserted on the ground serve as the foundation system. The pillars would not be tied at the plinth level; however, they would be tied at the eaves level with folded bamboo sheets. The wall system comprises the folded bamboo sheets or shrub shoots. The wall skeleton would be then plastered with the clay usually mixed with cow dung. The wall thickness would be uniform throughout the dwelling including the partition walls. As shown in Fig. 4a, the concrete pillars of a wattle and daub house were washed away by the flood. Due to the lack of adequate stiffness of walls and pillars, water current easily washed away the walls and pillars. We did not observe any connection to tie-up the structural system (pillars and walls), thus the effect of water current became more localized leading to the collapse of some parts of the house. Fig. 4b shows a washed away wattle and daub house that was fixed again for temporary use. It is worthy to note that the brittle damages in structural members were scarce; however, the poor connections and less depth of insertions on the ground fundamentally affected the performance of houses during flood. Fig. 4c shows the remains of a wall of wattle and daub house made up of bamboo pillars. As shown in Fig. 4c, a thin sheet of walls could be observed which leads to negligible stiffness against the water current during flooding. Fig. 4d displays a house with ejected and distorted concrete pillars together with some washed away wattle and daub walls. We measured the depth of inundation between 2–170 cm in the affected areas. The inundation depth of 2 cm had negligible to slight damage in houses; however, 170 cm depth of inundation led to complete collapse to beyond repair damage level.

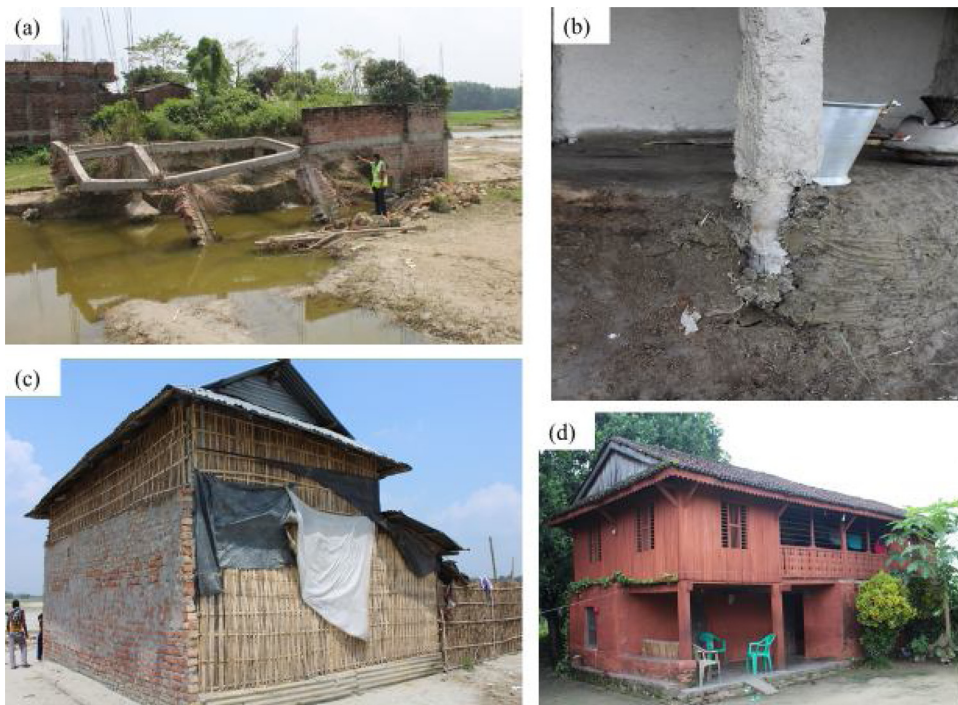
**Fig. 5.** a) A washed away under-construction reinforced concrete building, b) ejected concrete pole displays the marginal depth of insertion to the ground, c) single wythed brick wall construction in the direction perpendicular to likely flood direction, d) vernacular multi-wythed flood resilient construction practice in southern Nepal.

Nearby the East-West Highway in Saptari district, we observed a spectacular example of reinforced concrete (RC) building damage (Fig. 5a). At the depth of inundation of 2.5 m, the foundation of the building was washed away, and the frame was also heavily damaged. The building was under construction and we observed that the building was not code-conforming due to lack of adequate ductile detailing. The flooded water discharge got high velocity in a narrow channel passing through the foundation and heavy erosion occurred subsequently leading to the collapse the RC building. Fig. 5b shows an example of a concrete pillar inserted into the piled-up clay that serves as the plinth. It is obvious that once eroded, the pillars would distort or get washed away. In Fig. 5c, a mixed construction system could be observed that came into practice after the 2008 flood in the affected areas of Saptari and Sunsari

districts. The walls normal to the likely flood direction were made up of single wythed brick masonry to increase stiffness; however, the orthogonal walls were still constructed using wattle and daub system. It is interesting to note that the first story of the house is constructed with brick and the second story was continued with wattle and daub system; possibly due to the assumption that the flood may rise to the first story level only. Such construction systems are designated to be flood resilient. Similar resilient practices are also reported elsewhere (see e.g. (Gautam et al., 2016)). Fig. 5d shows a vernacular form of a residential building in which the first story is a multi-wythed brick masonry and the second story comprises timber construction. The construction system in southern Nepal is mostly governed by reinforced concrete, brick masonry, and wattle and daub, notably, the importance of wattle and daub is more than any other building form due to several reasons. The first is that the wattle and daub construction is the most popular

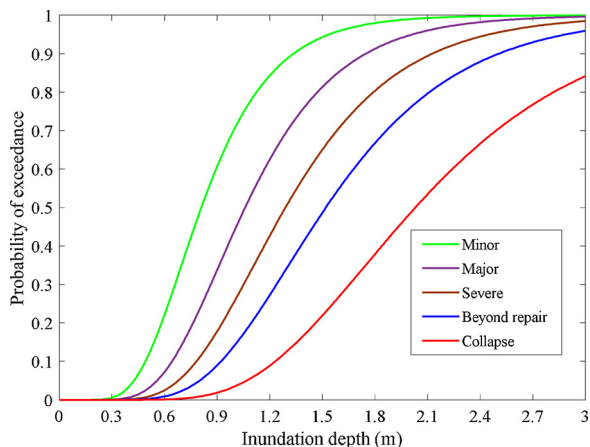
Fig. 7. Flood fragility functions for wattle and daub houses.

Based on the data collected during the field survey, we constructed a vulnerability curve for the wattle and daub construction system. The vulnerability curve considering the logit function was derived as shown in Fig. 6. As shown in Fig. 6, inundation up to 20 cm depicts the damage ratio less than 10 %, inundation of 50 cm leads to 20 % damage, inundation of 1 m leads to 50 % damage and inundation of 1.6 m results in 90 % damage to wattle and daub dwellings. Notably, slight to minor damages need scrutinized efforts to demarcate hence the lower inundation depths hardly contribute in construction of vulnerability curve, which is often regarded as the depth-damage curve. Obtaining discrete data points is challenging especially in the case of flood events because most of the heavily damaged and collapsed buildings would not show the actual impression of inundation depth. However, we assessed distinctly inundated and damage wattle and daub dwellings during the field survey. The inundation scenario comparable to the 2017 flood was reflected by the 20 years return period flood. The average inundation along the bank where the damage has occurred was ~ 1.5 m. Similarly, the average depth of inundation was also 1.5 m for the riverbank. This is evident that the 20 years return period can cause significant damage to wattle and daub buildings. Thus, to predict the probabilistic performance of wattle and daub constructions, vulnerability and fragility curves derived in this study play a vital role. Both vulnerability and fragility curves could be used to get the probability of damage/damage level exceedance for a particular inundation depth from any return period. At higher return periods, the inundation depth would be higher in general, the expected performance level or damage level of wattle and daub construction system could be estimated from Figs. 6 and 7.

depicted minor damage, 25 % depicted major damage, 18.75 % depicted severe damage, 25 % depicted beyond repair damage, and 18.75 % depicted collapse damage state. Considering the mean damage ratio for each damage state, lognormal distribution parameters were estimated. However, the quality of fragility functions was not satisfactory due to the limited database that resulted in intersecting curves. Thereafter, we re-assessed the quality of fragility functions considering the distribution of standard deviation per Eqs. 4 and 5.

As all the preceding fragility curve intersected the following curve, the redistribution of the lognormal standard deviation resulted in the same value for all five classes. However, significant variation in terms of median depth of inundation (m) was observed as shown in Table 1. The parameters were then plotted to obtain the fragility functions for five damage states as shown in Fig. 7. Fig. 7 highlights that up to the inundation depth of 30 cm, only minor damages are expected. Similarly, initiation of collapse with the probability of exceedance less than 5% is expected after the inundation depth of 75 cm. At a depth of 1.2 m, the probabilities of exceedance of collapse, beyond repair, severe, major, and minor damage states are respectively 10 %, 25 %, 40 %, 70 %, and 90 %. As 1.2 m depth of inundation is quite common during every monsoon in the southern plains of Nepal, it could be concluded that most of the wattle and daub houses would not be usable at this depth. Thus, there is an urgent need for improvement in the wattle and daub housing construction system to assure flood resilience. As the total cost of construction of wattle and daub houses ranges between US\$ 50–500, low-cost improvements are important because the owners cannot afford drastic improvements due to cost issues.
