Experiences on Retrofitting of Low Strength Masonry Buildings by Different Retrofitting Techniques in Nepal

Hima Shrestha, Suman Pradhan, Ramesh Guragain
National Society for Earthquake Technology-Nepal (NSET)

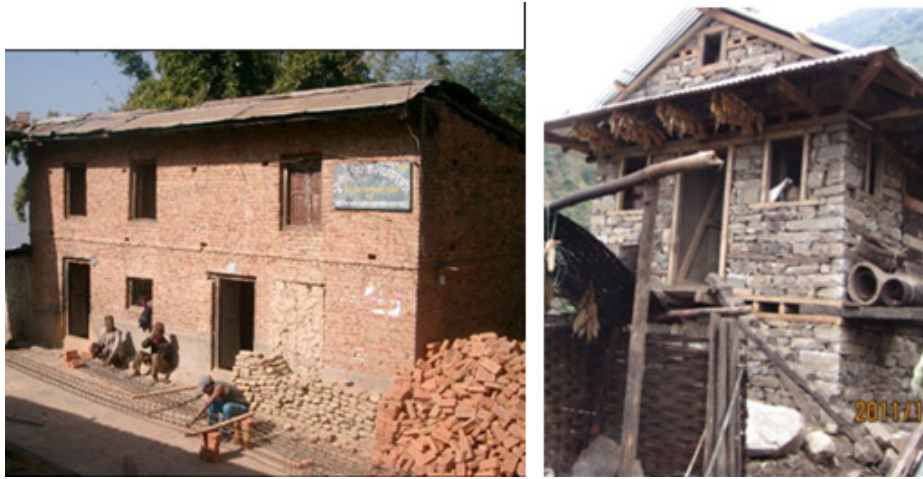
Fig 1.1 Typical brick (left) and stone (right) masonry buildings in Nepal

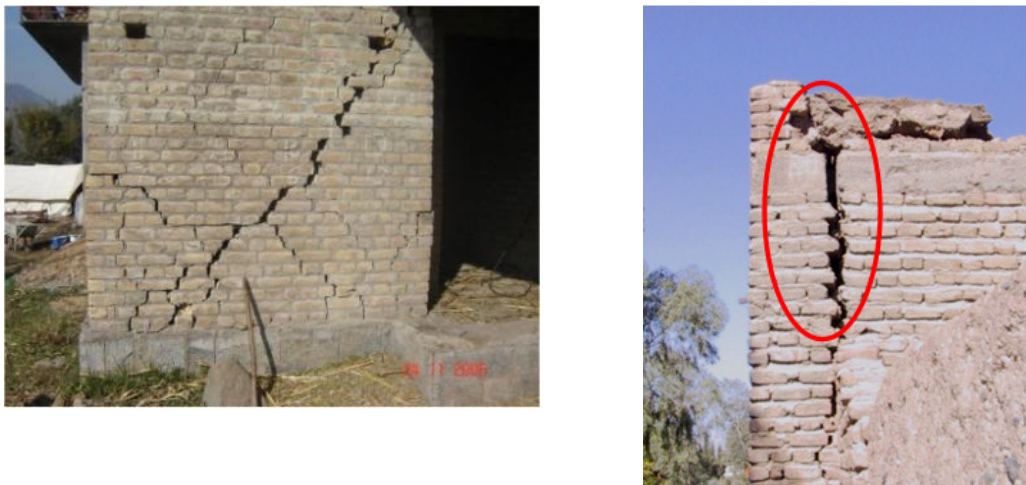
Fig 2.1 Diagonal shear failure, (left); Corner separation due to lack of integrity (right), 2005 Pakistan earthquake, Photo courtesy NSET

The damage and destruction in stone and brick masonry walls is attributed to the violation of the most basic rules of masonry construction, such as the absence of ‘through’ stones and ‘long corner’ stones in stone walls, use of mud mortar/lean cement mortar in stone or brick masonry, lack of proper connection between orthogonal walls or between the roof and walls, lack of proper workmanship and quality control, lack of cross walls and above all, the absence of earthquake resistant features, causing the building to fail in a brittle manner rather than in a ductile manner. A large number of masonry buildings suffered severe damage through past earthquakes, indicating the high level of seismic vulnerability in the region . The most common damage patterns are corner separation, formation of cracks near the corners and at openings, out-of-plane tilting of walls, collapse of roof etc. Improvement in construction practice and maintaining the integrity of the building structure, can significantly enhance the earthquake resistant performance of such buildings.

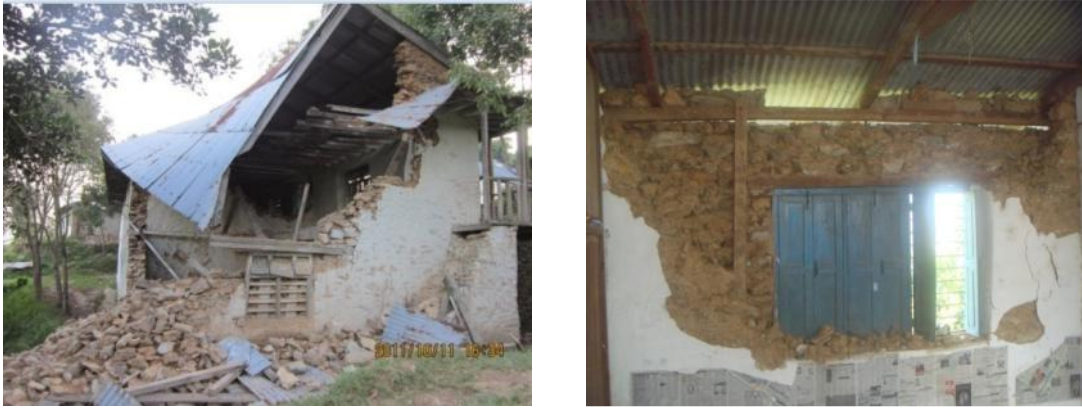
Fig 2.2 Failure of roof connection to wall (left); Collapse of inner wythe of stone wall due to lack of through stone (right), 18th Sept 2011 Taplejung Nepal earthquake, Photo courtesy NSET

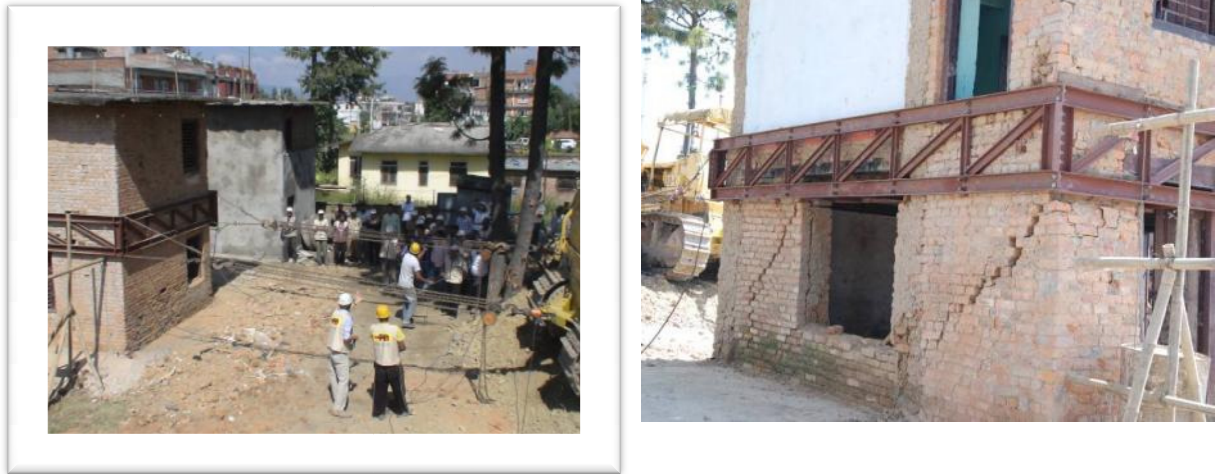
Fig 3.2 Loading arrangement (left) and crack propagation (right) during pull down test of non-retrofitted building

A pull down test has been carried out to assess the effectiveness of this system in the seismic upgrading of the existing buildings in Nepal. For this, two, full scale, identical brick in mud buildings were used, one in its original condition and the other with seismic retrofitting, using galvanized wire mesh. 16 gauge galvanized wire mesh @ 19 mm c/c spacing was anchored on both faces of the wall and plastered with cement sand mortar of ratio 1:3. Holes were drilled through the wall to fix the galvanized wire with cross wires, staggered @800 mm c/c.

The pulling forces vs. roof displacement, i.e. the pushover curve of the buildings, were developed from the experimental test. The loading was applied gradually to avoid dynamic amplification of stresses. Two load cells of 20 ton capacity were used to record the applied loads on each building. Three displacement transducer gauges, of 25mm measuring capacity, were used to record the small displacements induced by each increment of load. Two displacement transducer gauges of capacity 500mm were used to measure large displacements, beyond the elastic and plastic limits. Light sensors were used to capture the collapse pattern by still camera. A data logger was used to communicate the signals between the transducer and PC.

The mud mortared non-retrofitted building collapsed under a pulldown loading of 17 tons, as compared with the estimated 19.0 ton collapse loading of the numerical modelling. The numerical model indicates that the wire mesh retrofitting and plastering, increases the rigidity of the structure within the elastic limit and can resist large deformations in plastic range. The experimental results indicate an increase in rigidity of the structure within the elastic limit, with 3.5 mm displacement under 26.3 tons of loading, with no visible cracks. The building could sustain further loading but it could not be tested above 26.3 ton due to limitations of test set up. The retrofitted building sustained 1.55 times the pulldown load as compared with the similar non-retrofitted building, without any visible cracks and an estimated load carrying capacity of 2.47 times the pulldown load from numerical calculations [NSET, December, 2009]. Both analytical and experimental results concluded that this upgrading technique significantly increases the strength and stiffness of the buildings. If adequately implemented, the system will improve the performance of the buildings during future earthquakes.

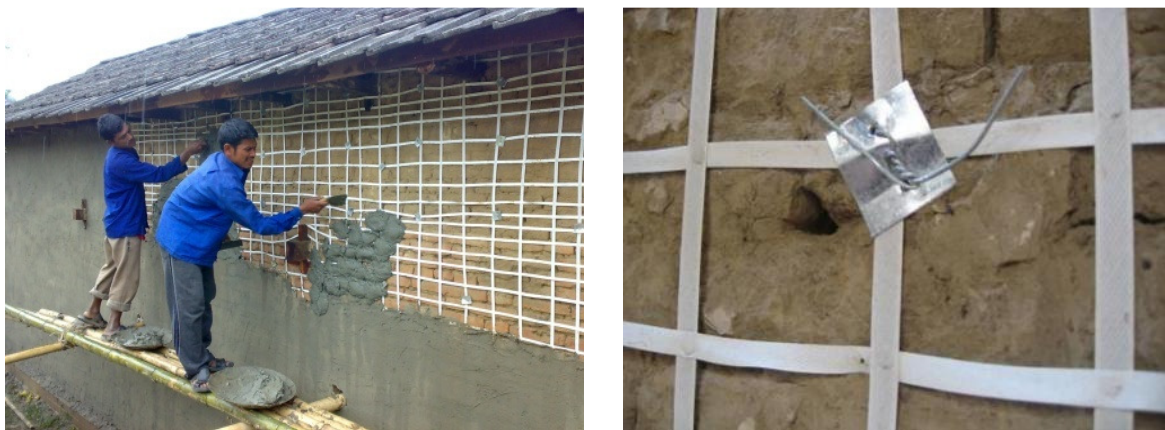
Fig 3.5 Implementation of PP band method of retrofitting in Kathmandu Valley (left) and anchorage throughout the wall (right)

Polypropylene meshing uses common polypropylene packaging straps (pp-bands) to form a mesh which is used to encase masonry walls, preventing both collapse and the escape of debris during earthquakes. PP-bands are used for packaging all over the world and are therefore cheap and readily available while the retrofitting technique itself is simple enough to be suitable for local builders. PP-meshing has been applied in Nepal, Pakistan and more recently in China.

This method is most readily applicable in terms of low-cost upgrading of traditional structures to limit damage caused by normal earthquakes and give occupants a good chance of escape in a once-in-a-lifetime large earthquake. Non-engineered masonry is widespread throughout the developing world and replacement of all such dwellings is both unfeasible and undesirable, given that they are often the embodiment of local culture and tradition. It is therefore often more feasible to consider low-cost retrofitting of such buildings. Experiments and advanced numerical simulations have shown that PP-band mesh can dramatically increase the seismic capacity of adobe/masonry houses [P. Mayorka and K Meguro, 2008]. This is mainly achieved by increasing the structural ductility and energy dissipation capacities. Under moderate ground motions, PP-band meshes provide enough seismic resistance to guaranty limited and controlled cracking of the retrofitted structures. Under extremely strong ground motions, they are expected to prevent or delay the collapse, thus, increasing the rates of survival. Experimental verification (full scale) was done in the laboratory of Tokyo University [Nesheli K et al, 2006] and also in Kathmandu, (small scale 1:6) demonstrating reliable performance improvement in the integrity of the structure and preventing material loss. This method is good for one storey buildings and can be used for a maximum of two storeys. To protect the Polypropylene from ultra violate rays, mud plaster is used on the outside, providing adequate cover to ensure the durability of the material.

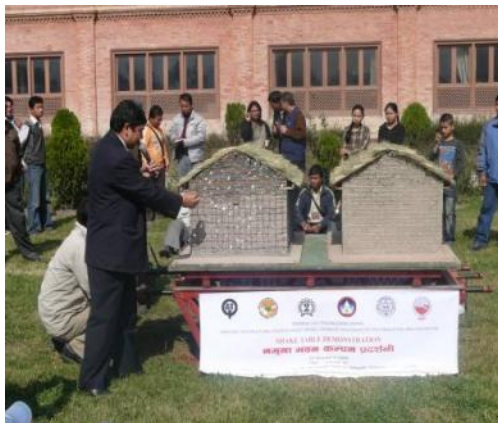
Fig 3.6 Two identical buildings with and without retrofitting by PP Band before shake table

In order to demonstrate the seismic response of the target building, with and without PP-band mesh retrofitting, and to compare crack patterns, failure behavior, and overall effectiveness of the retrofitting technique, a shake table test was carried out. The test verified that PP-band mesh retrofitting significantly improves the performance of the masonry building structures, maintaining the structural integrity with sufficient energy dissipation through extensively developed cracks [NSET, June 2009]. The general process of retrofitting by PP Bands includes 1) Plan modifications such as adding or removing solid walls, changing door/window openings, if required, to balance wall stiffness in both directions 2) Chipping off the wall plaster 3) Fixing of base anchor beam and tying on either side of the wall 4) Fixing of vertical PP Band starting from the outer anchor beam and ending at the inner anchor beam (this is feasible with flexible timber flooring) 5) concreting of anchor beam 6) Meshing the horizontal PP band on vertical PP band then connecting horizontal PP-Band with vertical PP-Band by Welder 7) Connecting inner and outer mesh with wires and aluminum plates 8) connecting roof elements with wall and bracing of roof 9) Mud plaster on wall to protect PP Band from ultraviolet rays.

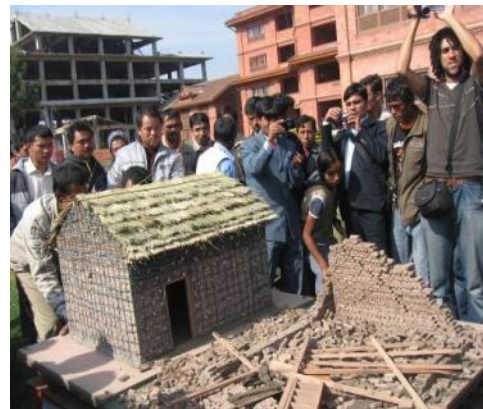
Fig 3.7 Shake table result' Non-retrofitted building collapse while retrofitted building is standing
