Gujarat Relief Engineering Advice Team (GREAT)
GREAT Publication: June 2001

Repair and strengthening guide for earthquake damaged low-rise domestic buildings in Gujarat, India

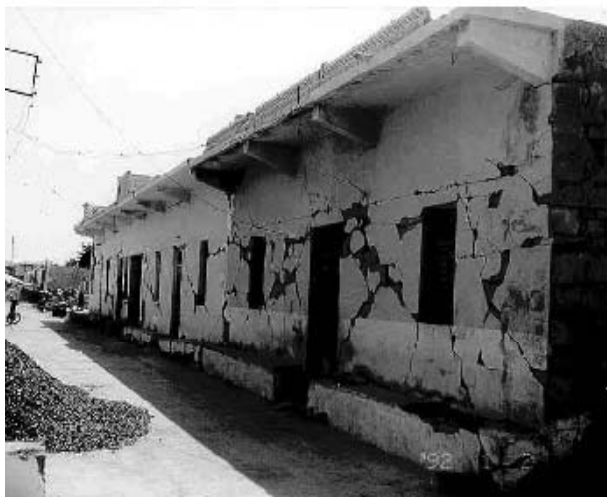
Figure 3.3 – Heavily damaged single storey rubble masonry wall with concrete roof in Manukawa & Sukhpur.

Note:

Walls survived due to diaphragm action from roof. Cantilever beams embedded in walls also helped this. Note window openings are also not close to corners.
